# Transformer Fire Isolated

Tightly packed Las Vegas Strip substation experiences a dramatic transformer fire, but high-tech firewalls protect nearby equipment.

By **Gordon Smith**, *NV Energy*

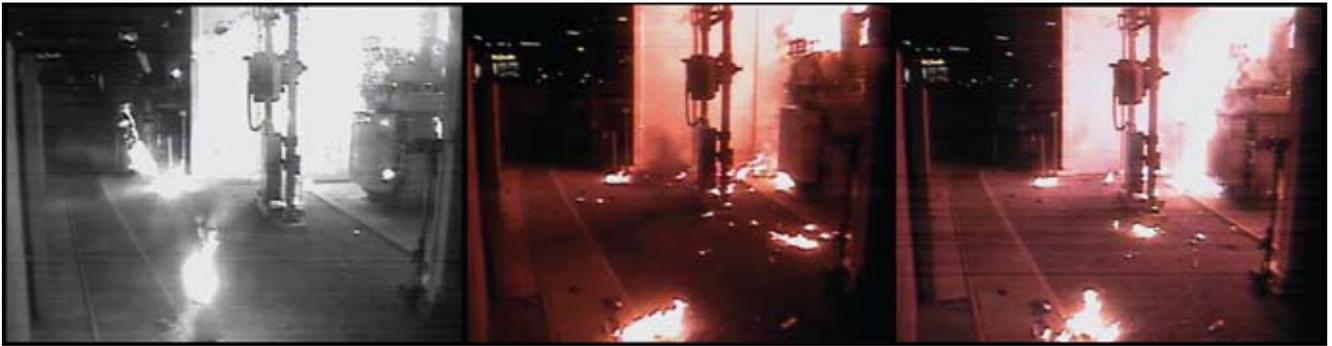
These are frames from the security camera in the Sinatra Station. Note how the first frame seems to be black and white, until the developing transformer fire starts to provide some more colorful lighting.

At 12:15 a.m. on Sunday, May 15, 2011, an explosion and fire occurred at the Sinatra substation. As a result of the fire, numerous pieces of the bushings flew off the large 230/138-

kV autotransformer and became embedded in the firewalls. Fueled by the transformer's mineral oil, the fire quickly engulfed the entire transformer. Observers from nearby hotels and the interstate saw flames shoot into the dark sky, which some estimated to be as high as 80 ft (24 m). The incident made national news.

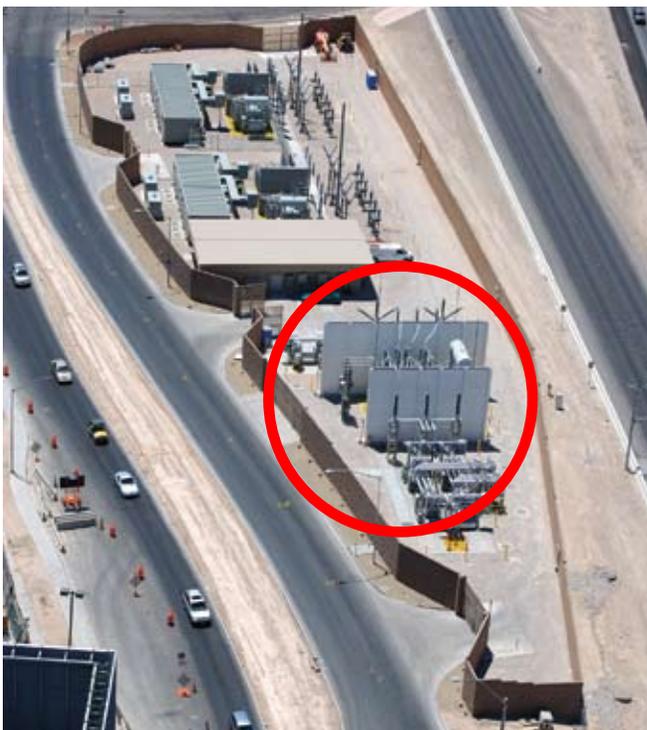
Aerial view of the entire Sinatra substation showing the location of the fire.

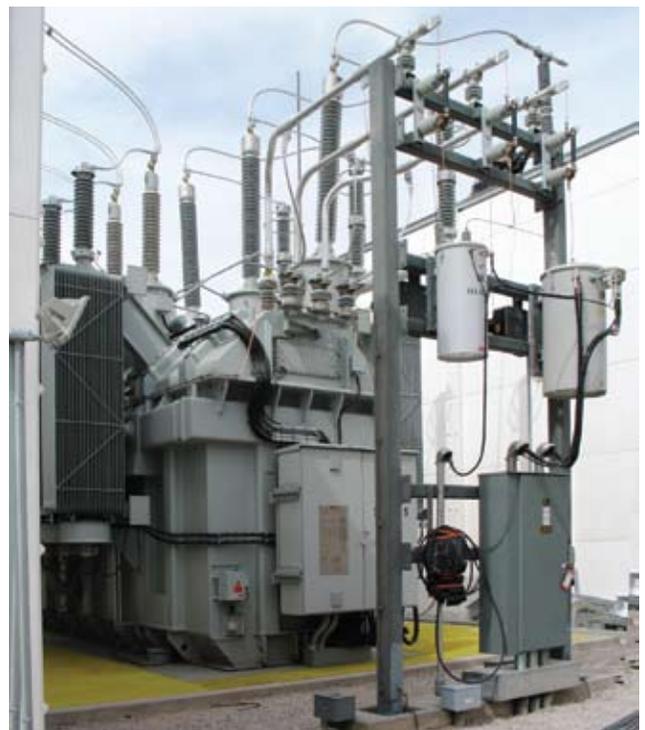
The 230/138-kV autotransformer tucked between the two ceramic panel firewalls before the fire.

sary safety protections and competitive pricing with more traditional concrete firewalls. The substation designers specified two Intelli-Firewalls from Composite Support & Solutions Inc. These two walls — which measured 41 ft wide by 28 ft tall (12.5 m by 8.5 m) and 58 ft wide by 28 ft tall (17.7 m by 8.5 m) — were designed to withstand a hydrocarbon fire for up to four hours.

The modular panels were relatively lightweight at 320 lb (145 kg) each, and easy to maneuver and install. Each hollow panel used a heat-resistant surface similar to what has been used on NASA space shuttle tiles. In the case of the tight-spaced Sinatra substation, the panels also offered the flexibility of easy removal and reassembly, should NV Energy find it necessary to replace or maintain the large 230/138-kv autotransformer. In fact, a single wall can be assembled or disassembled in less

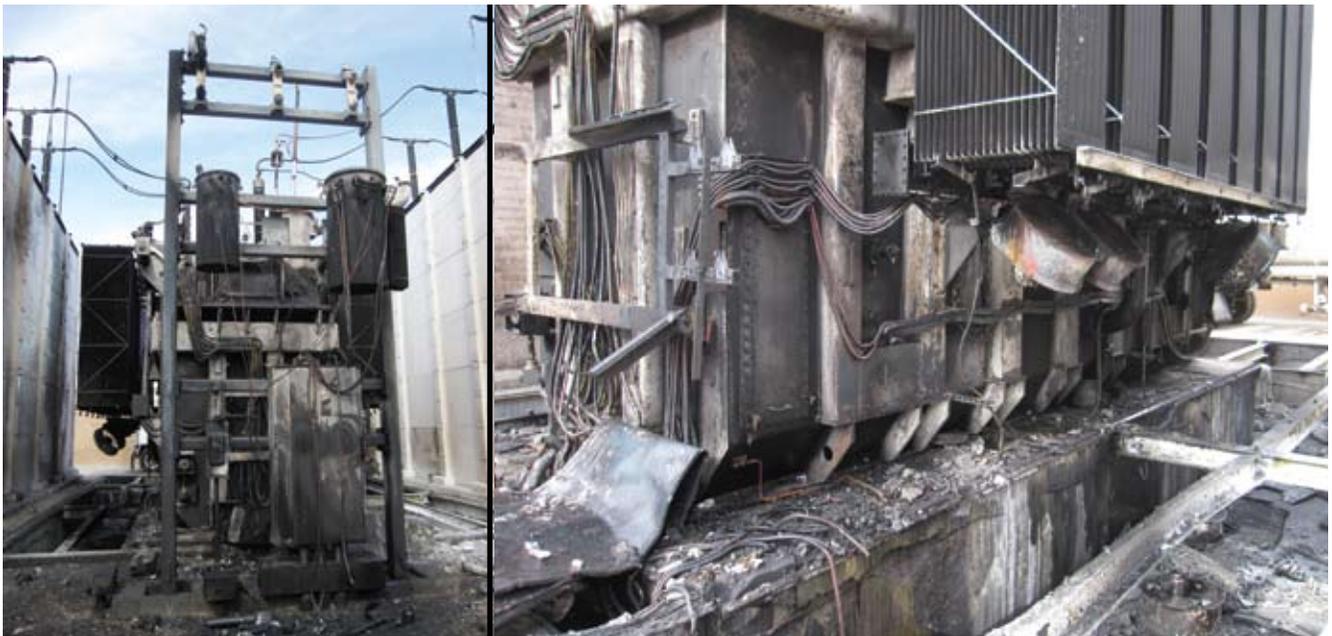
Front and side views of the burned unit with the tertiary structure beside it, although all the equipment on this structure was destroyed, NV Energy was able to repaint and put the steel structure back in service.

In spite of the initial explosion and sustained oil-fed fire, both firewalls that bookended the autotransformer were remarkably intact. More importantly, the GIS equipment located behind the firewalls was protected from the heat and explosion. It was not damaged and remained available for service. The autotransformer was a total loss, naturally.

eration of removing and replacing the damaged panels and bringing the firewalls back into service in only a few days. In short, crews removed the damaged firewall sections and beam covers, replaced them and repainted the protective walls. They removed the burnt transformer. The intense heat from the transformer fire had resulted in the spalling and flaking of the concrete foundation, which had exposed the reinforcing bars in some places. Because of that severe damage, a new foundation was constructed and a replacement transformer was set into place. A spare 230/138-kV autotransformer was on hand, and NV Energy returned the substation to full service in just four months.

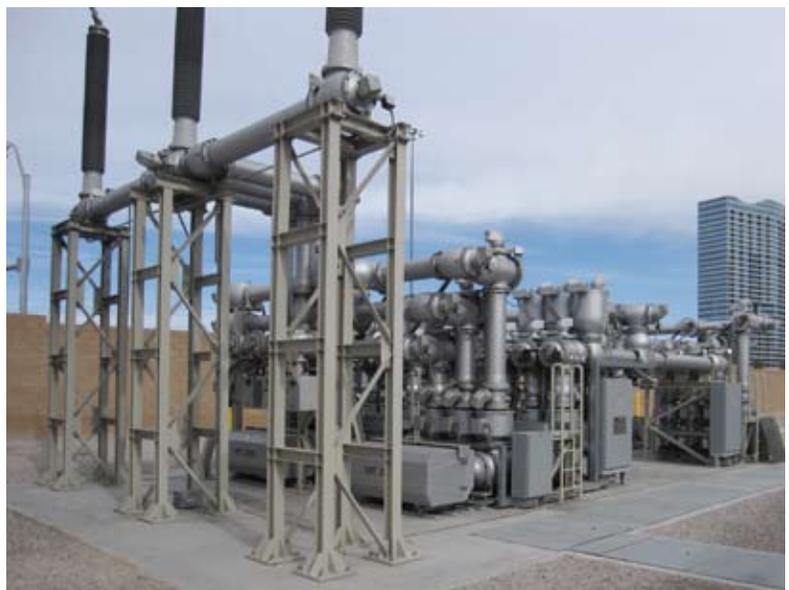
The undamaged 230-kV GIS equipment was protected by the firewalls.

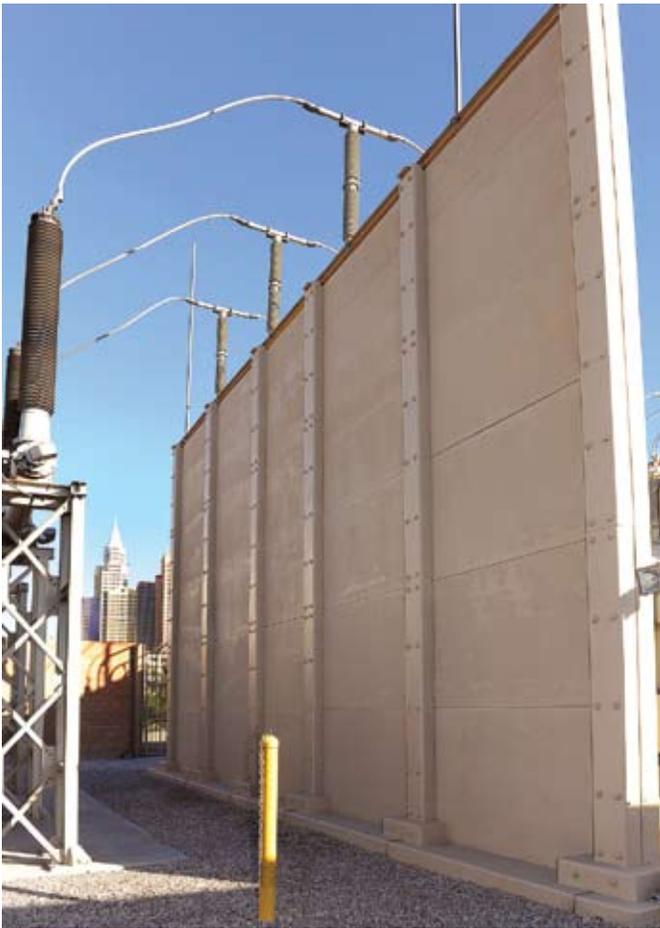
The firewall is restored and none the worse for having lived up to its design function.

The exploding porcelain bushings damaged several of the firewall panels. In fact, one side of the wall was penetrated and, in some cases, the shards became embedded in the firewall panels. Because the panels are fabricated with a hollow space inside, this posed no risk to the structural integrity and they performed as designed.

Fortunately, the majority of the panels were not penetrated, and they were tap-tested to determine their structural integrity. This testing is possible because the Intelli-Firewall is built with hollow "web-core" sandwich panels. A tap hammer — in the hand of an experienced operator — is an effective and simple way to determine the integrity of each panel. This test process, which does not require disassembly, can be done relatively quickly.

In spite of the fierce and prolonged fire on both sides of the autotransformer, only 12 panels had to be replaced. Additionally, several of the vertical beam covers were damaged in the fire and had to be replaced. Again, this was done relatively quickly and did not require any additional maintenance, restoration or replacement of the structural beams.

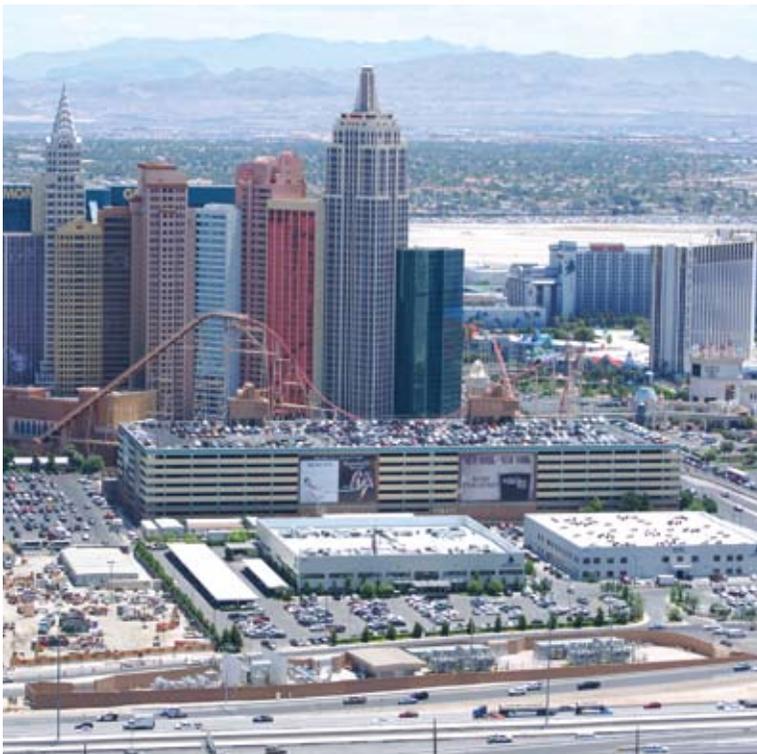
Aerial view of the Sinatra substation looking toward the strip.
